NASA Contractor Report 187092

Advanced Development Receiver Thermal Vacuum Tests With Cold Wall

Final Report

Leigh M. Sedgwick
*The Boeing
Company
Seattle, WA*

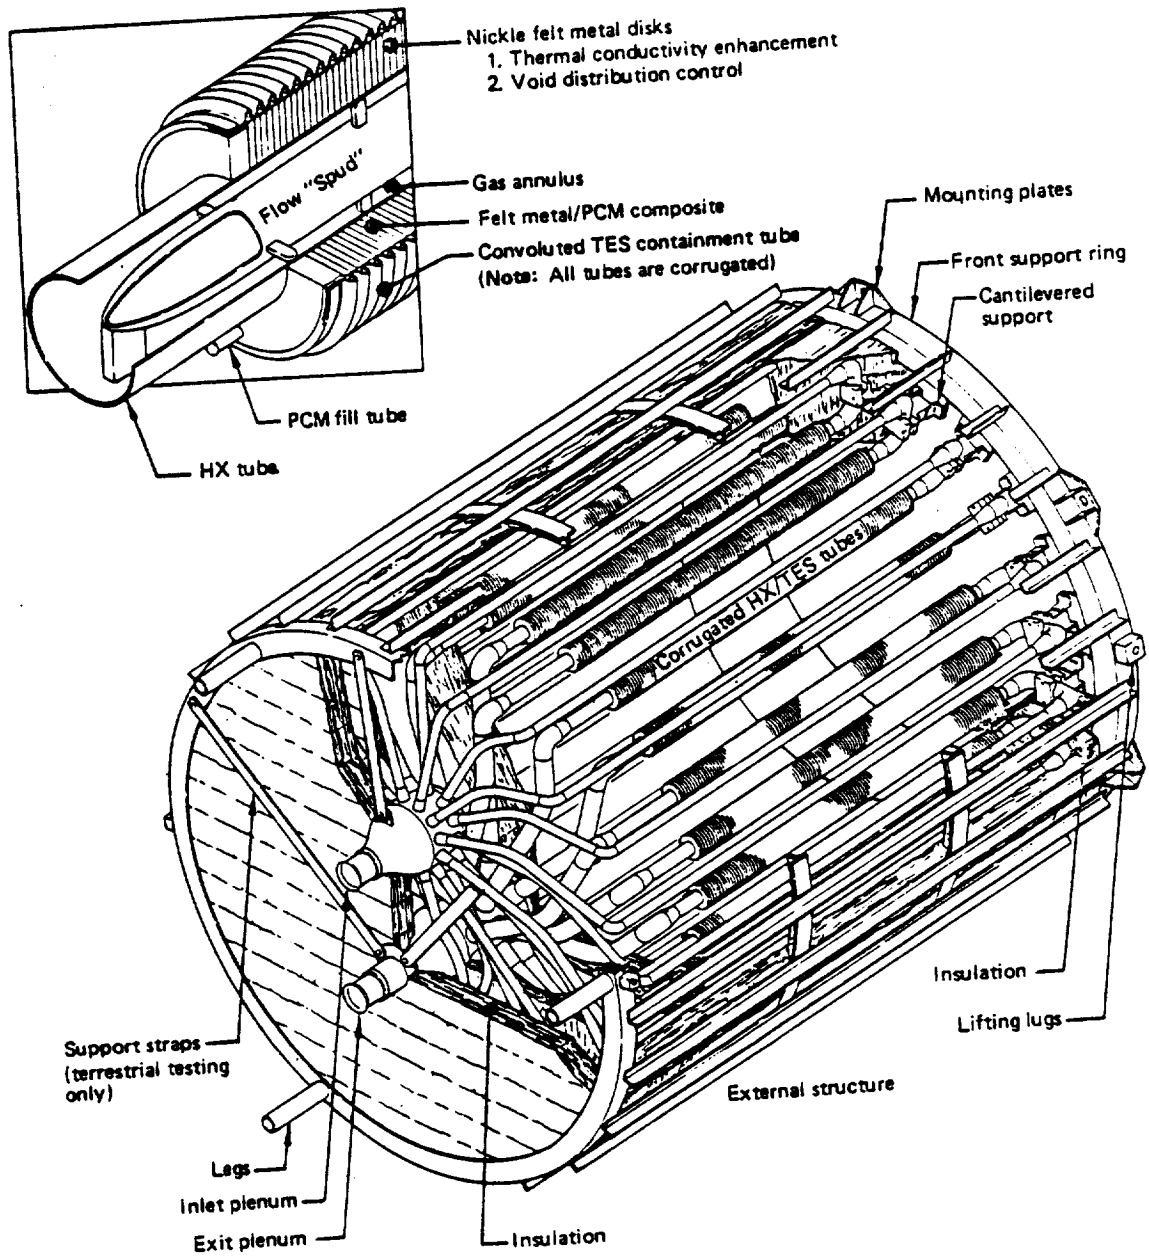
Figure 3-1: SDHRT Heat Receiver Design Configuration.

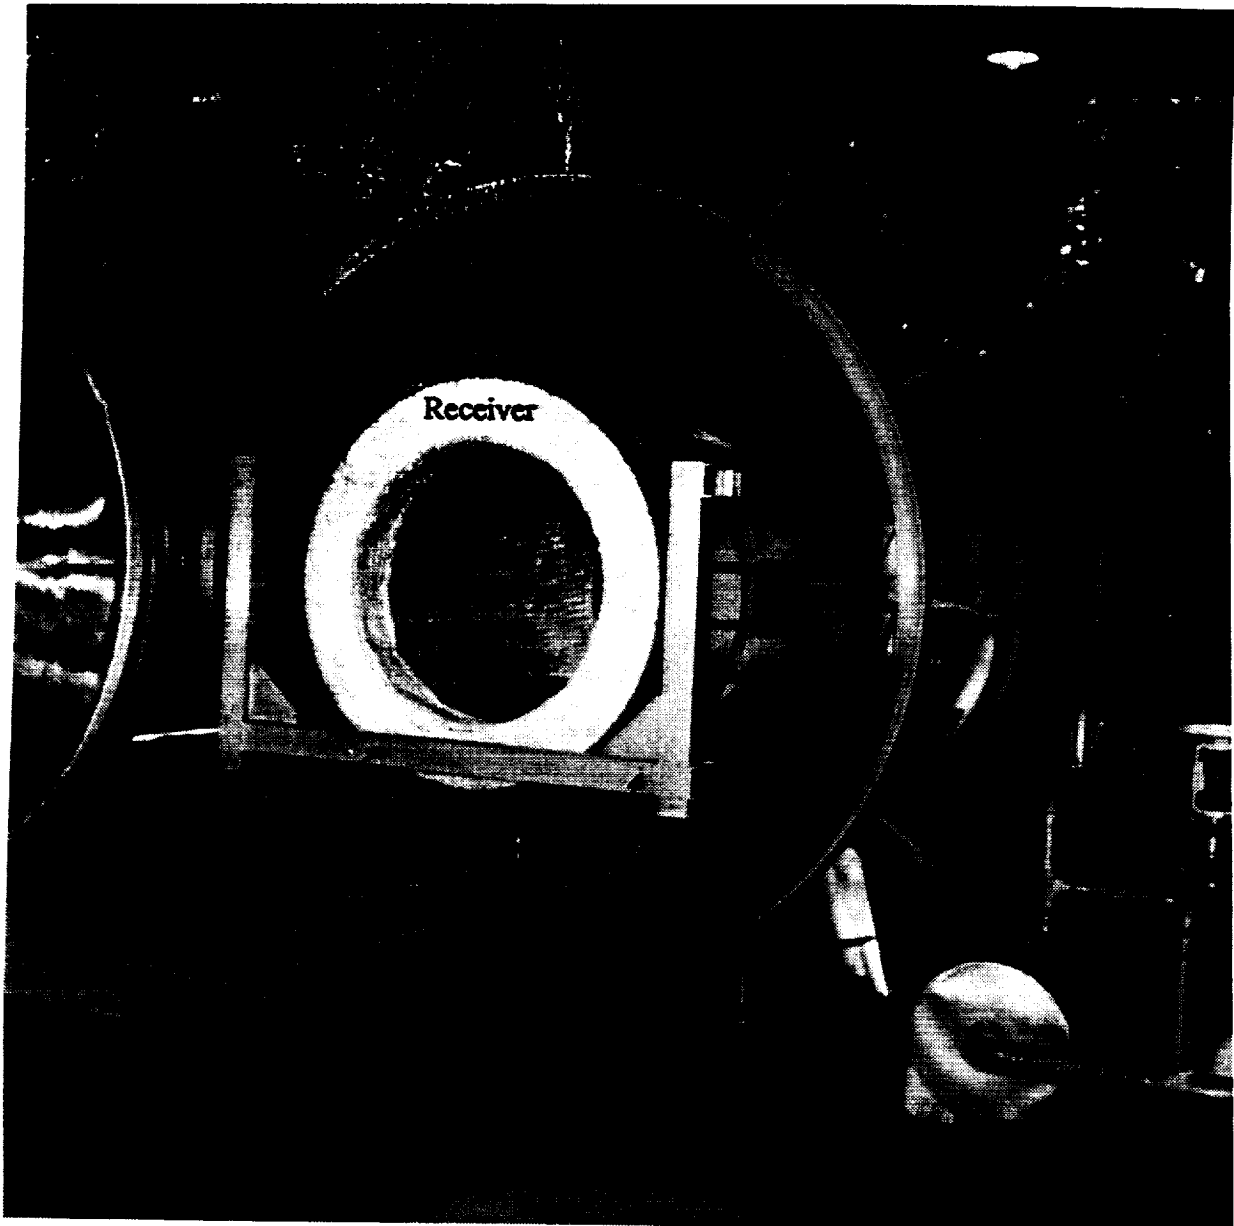
Figure 3-2: SDHRT Heat Receiver Mounted in Support Cart During Preparation for Testing.

The receiver is suspended in the vacuum chamber by the receiver support cart pictured in Figure 3-2. This structure also supports the back end of the quartz lamp array and the aperture cold plate. It is designed to roll out of the vacuum chamber onto a portable platform that mates up to the front of the chamber. This platform can also be seen in Figure 3-2. The cart/platform interface allows the quartz lamp heater array to be assembled and mated with the receiver while outside the vacuum chamber. The entire assembly is then rolled into the vacuum chamber on rail tracks installed inside the vacuum chamber. The rolling capability of the support cart inside the chamber also allows the receiver to roll forward as the inlet and exit pipes connecting the receiver to the CBC engine simulator grow in length during their initial heat up to operational temperatures. Redundancy in growth accommodation is also provided by the cable support of the receiver inside the support cart itself.

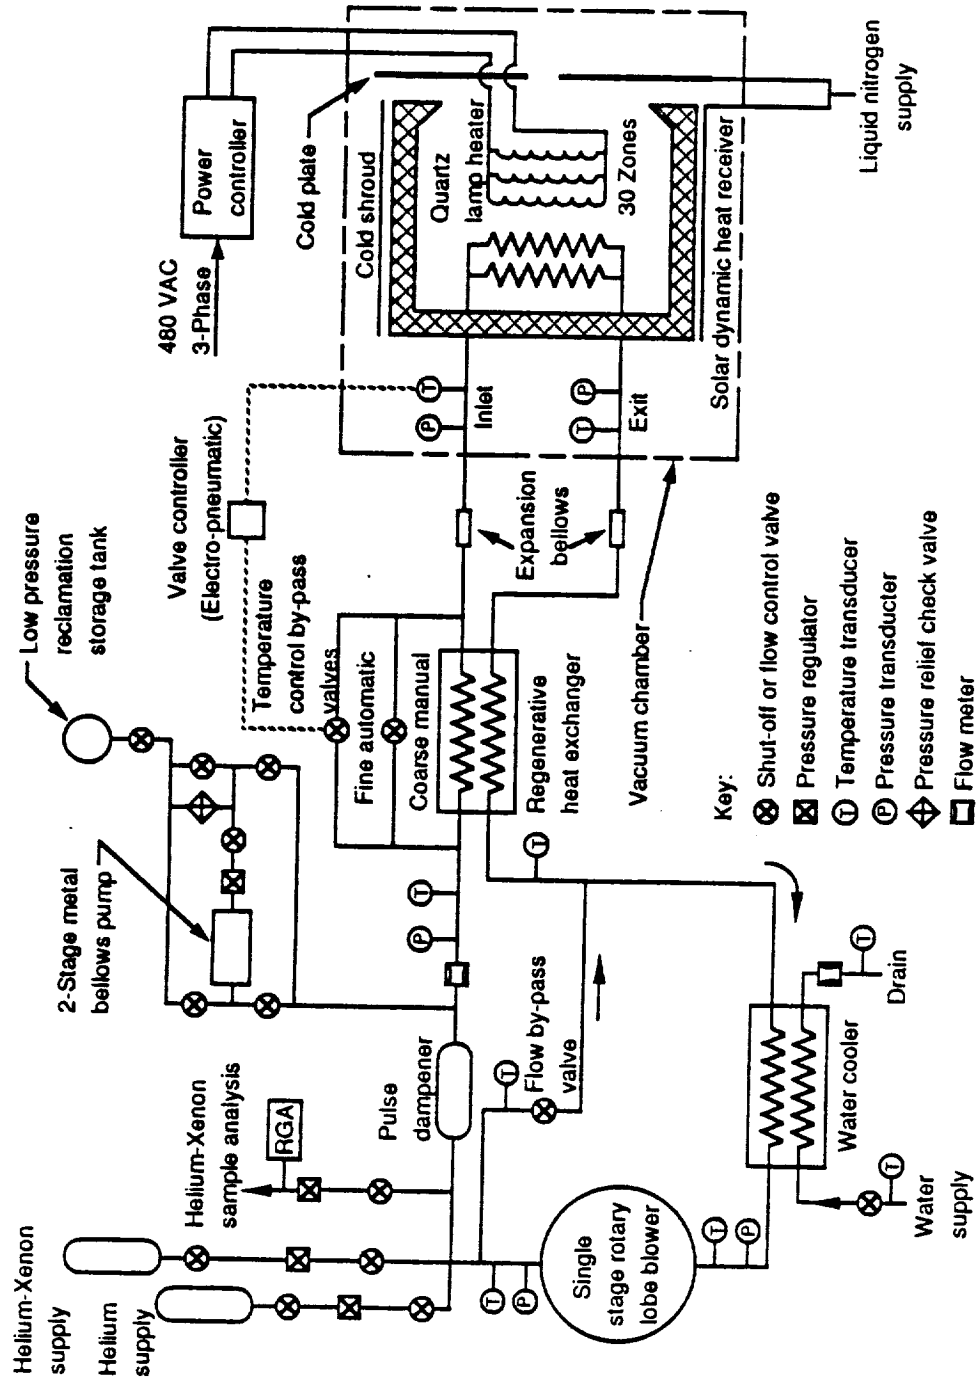
Figure 3-3: CBC Engine Simulator Functional Schematic.

The CBC engine simulator, supplied as GFP from the SDHRT program, is used to properly condition the receiver working fluid to the desired test mode conditions. Figure 3-3 shows a functional schematic of the CBC engine simulator which is pictured in Figure 3-4.

The temperature control of the gas at the receiver inlet is achieved using a regenerative heat exchanger by-pass system consisting of 2 flow control valves in parallel. A large, coarse control valve is set manually to produce gas at the exit of the regenerator that is slightly higher in temperature than the desired inlet value. A smaller, fine metering control valve with temperature feedback then modulates the bypass flow of cool gas to achieve a mixed gas temperature at the desired inlet conditions. The temperature of the gas is measured just upstream of the inlet plenum on the heat receiver and controls temperature to within $\pm 6^{\circ}\text{C}$ ($\pm 10^{\circ}\text{F}$) of the desired set point. The temperature controlled feed-back system was provided by Boeing as facility hardware. The fine control valve is designed to fail full open (fail-safe) to prevent over-heating of the receiver if an air pressure failure occurs.

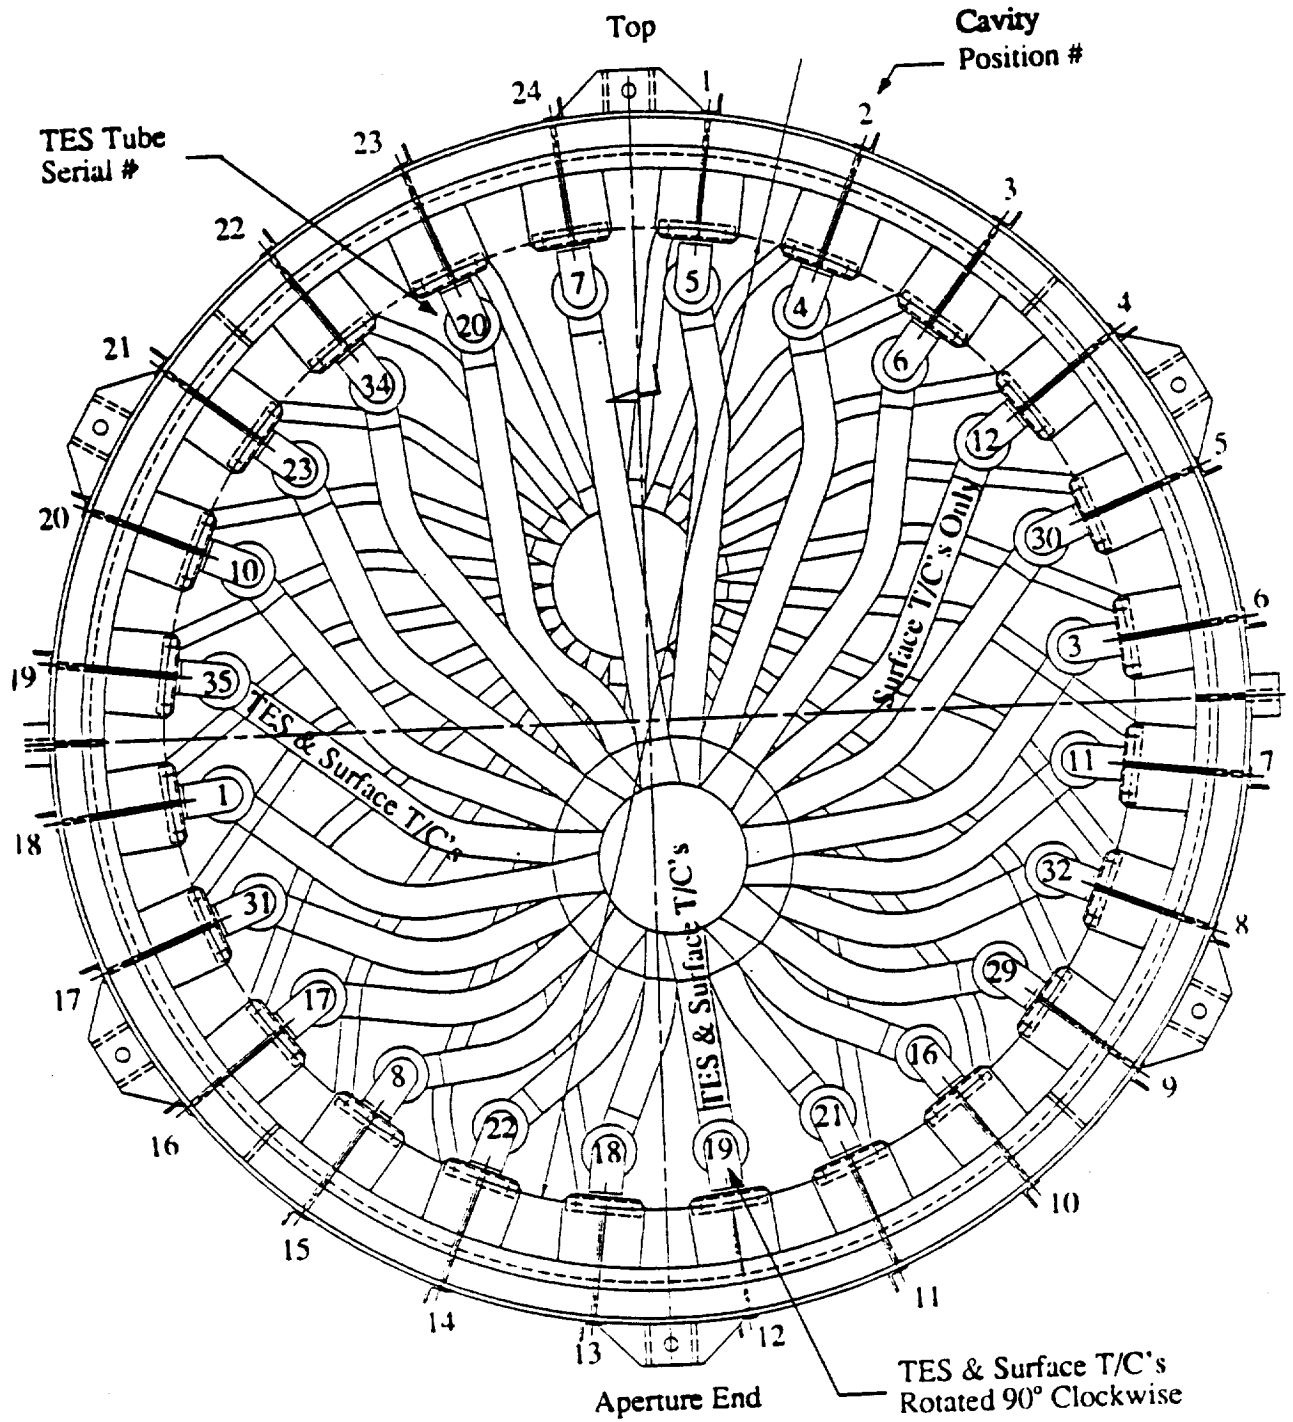
Figure 3-7: Location of Instrumented Heat Storage Tubes Inside the Receiver Cavity.

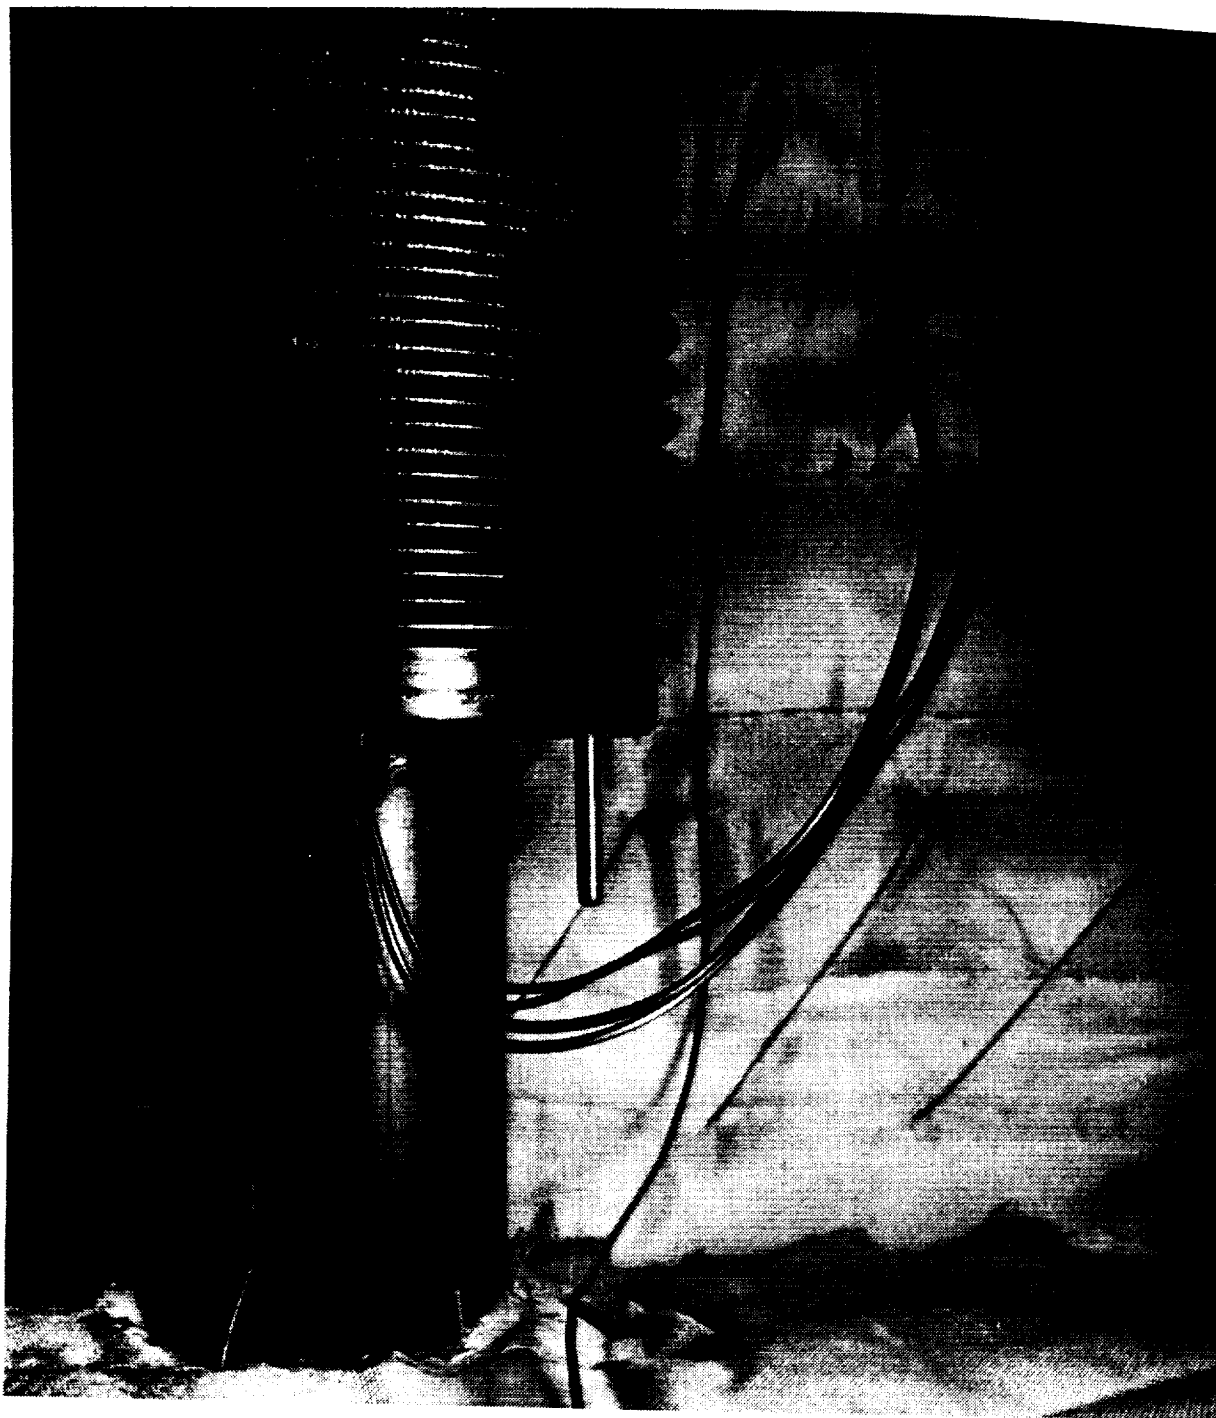
Figure 3-8: Internal Thermocouples at the Exit End of Heat Storage Tube #19.

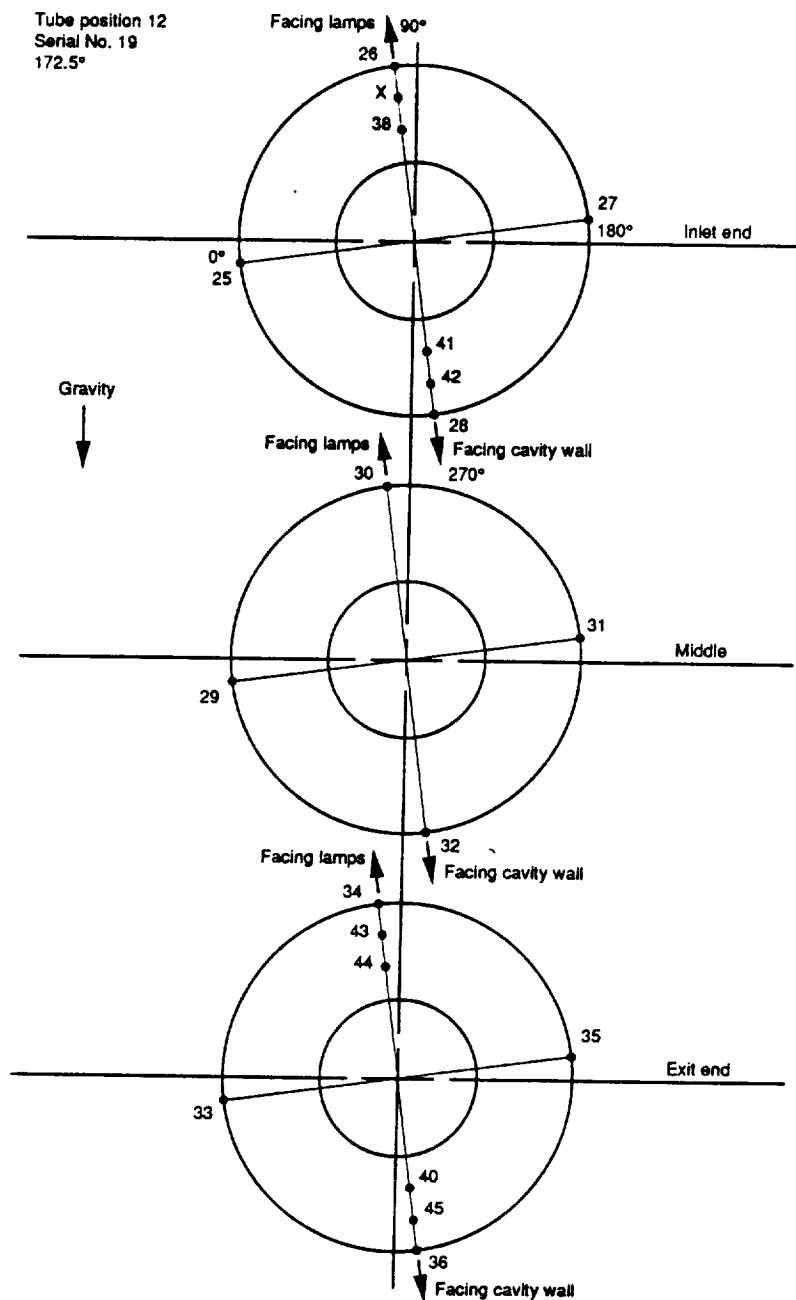
Figure 3-11: Thermocouple Alignment With Respect to Flux, Cavity Wall, and Gravity for Heat Storage Tube #12.

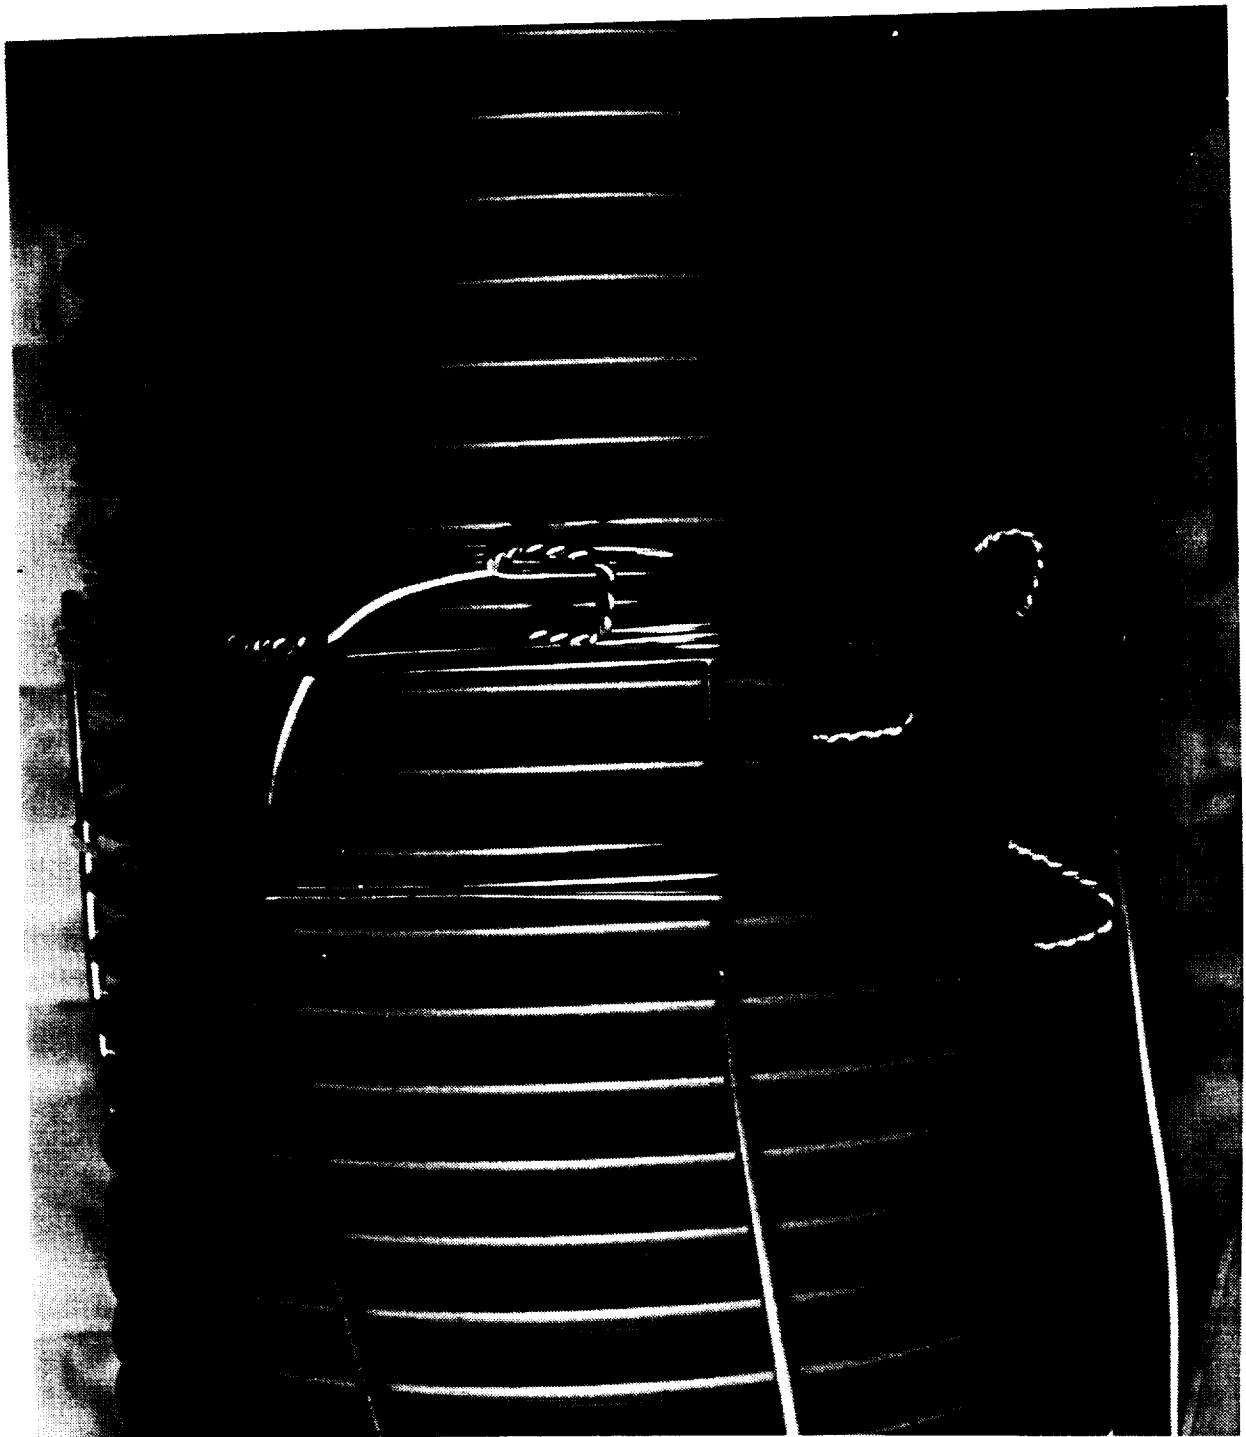
Figure 3-13: Close Up Showing the Thermocouple Attachment to the Convolution Peaks and Valleys at the Inlet End of Heat Storage Tube #4.

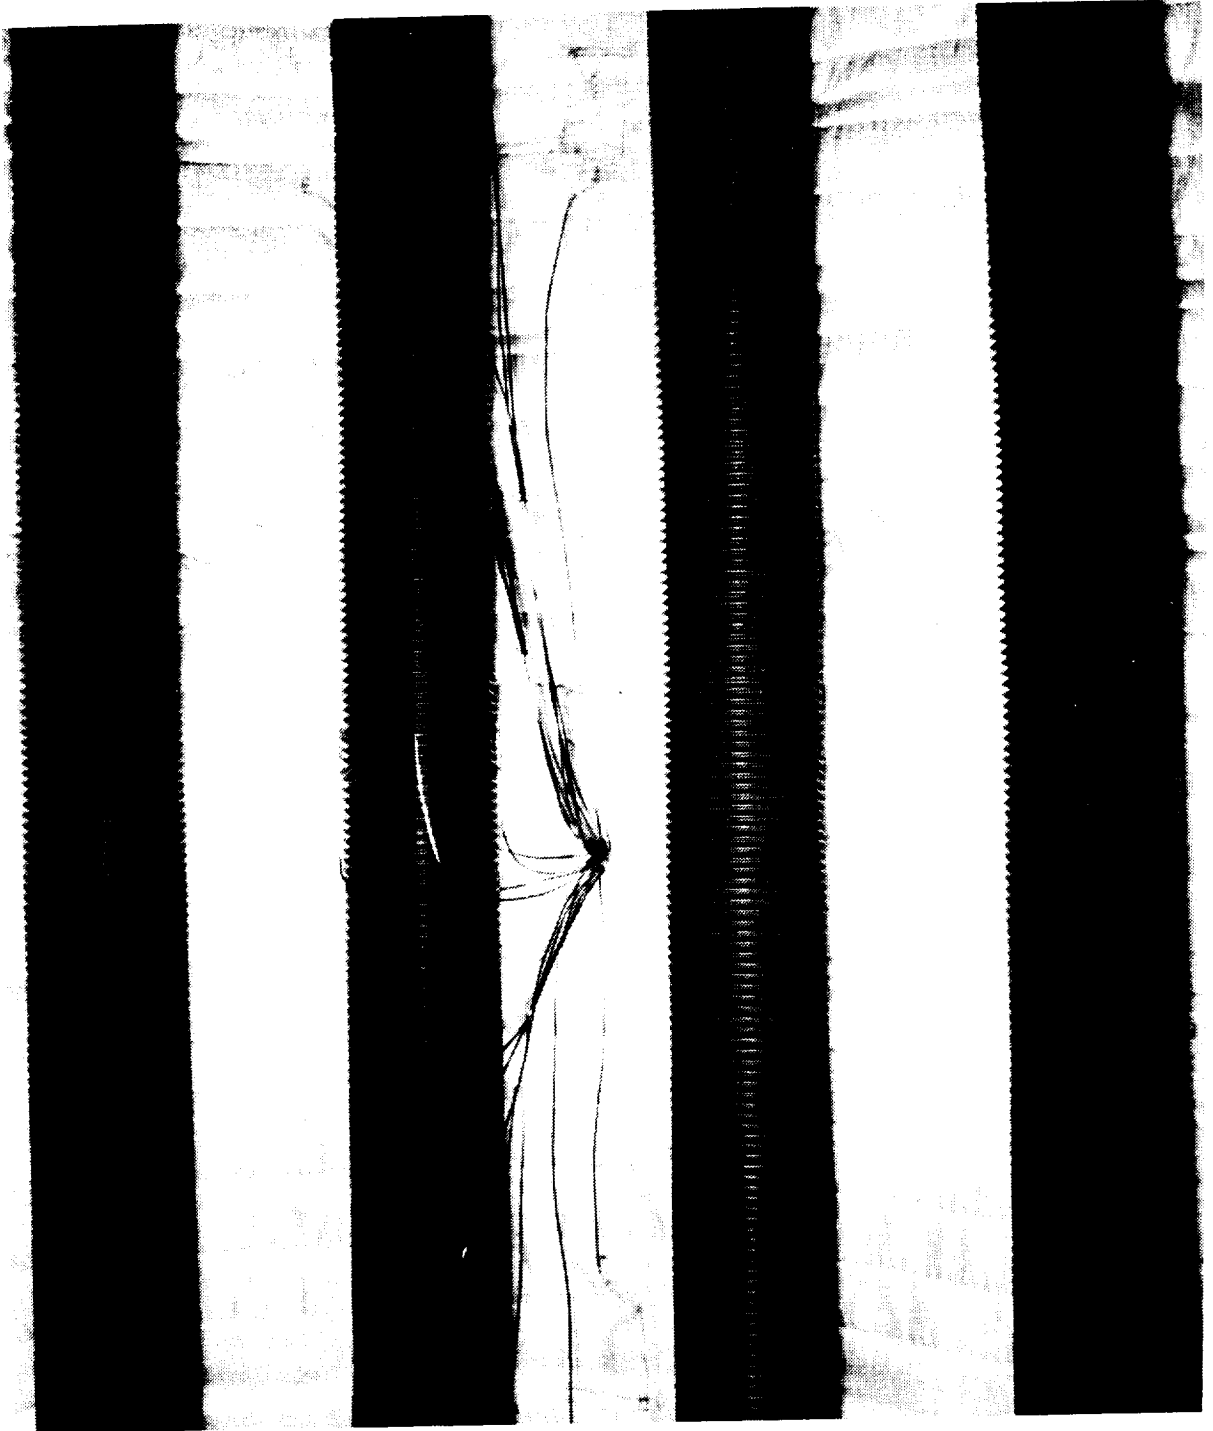
Figure 3-12: Instrumented Heat Storage Tube #4.

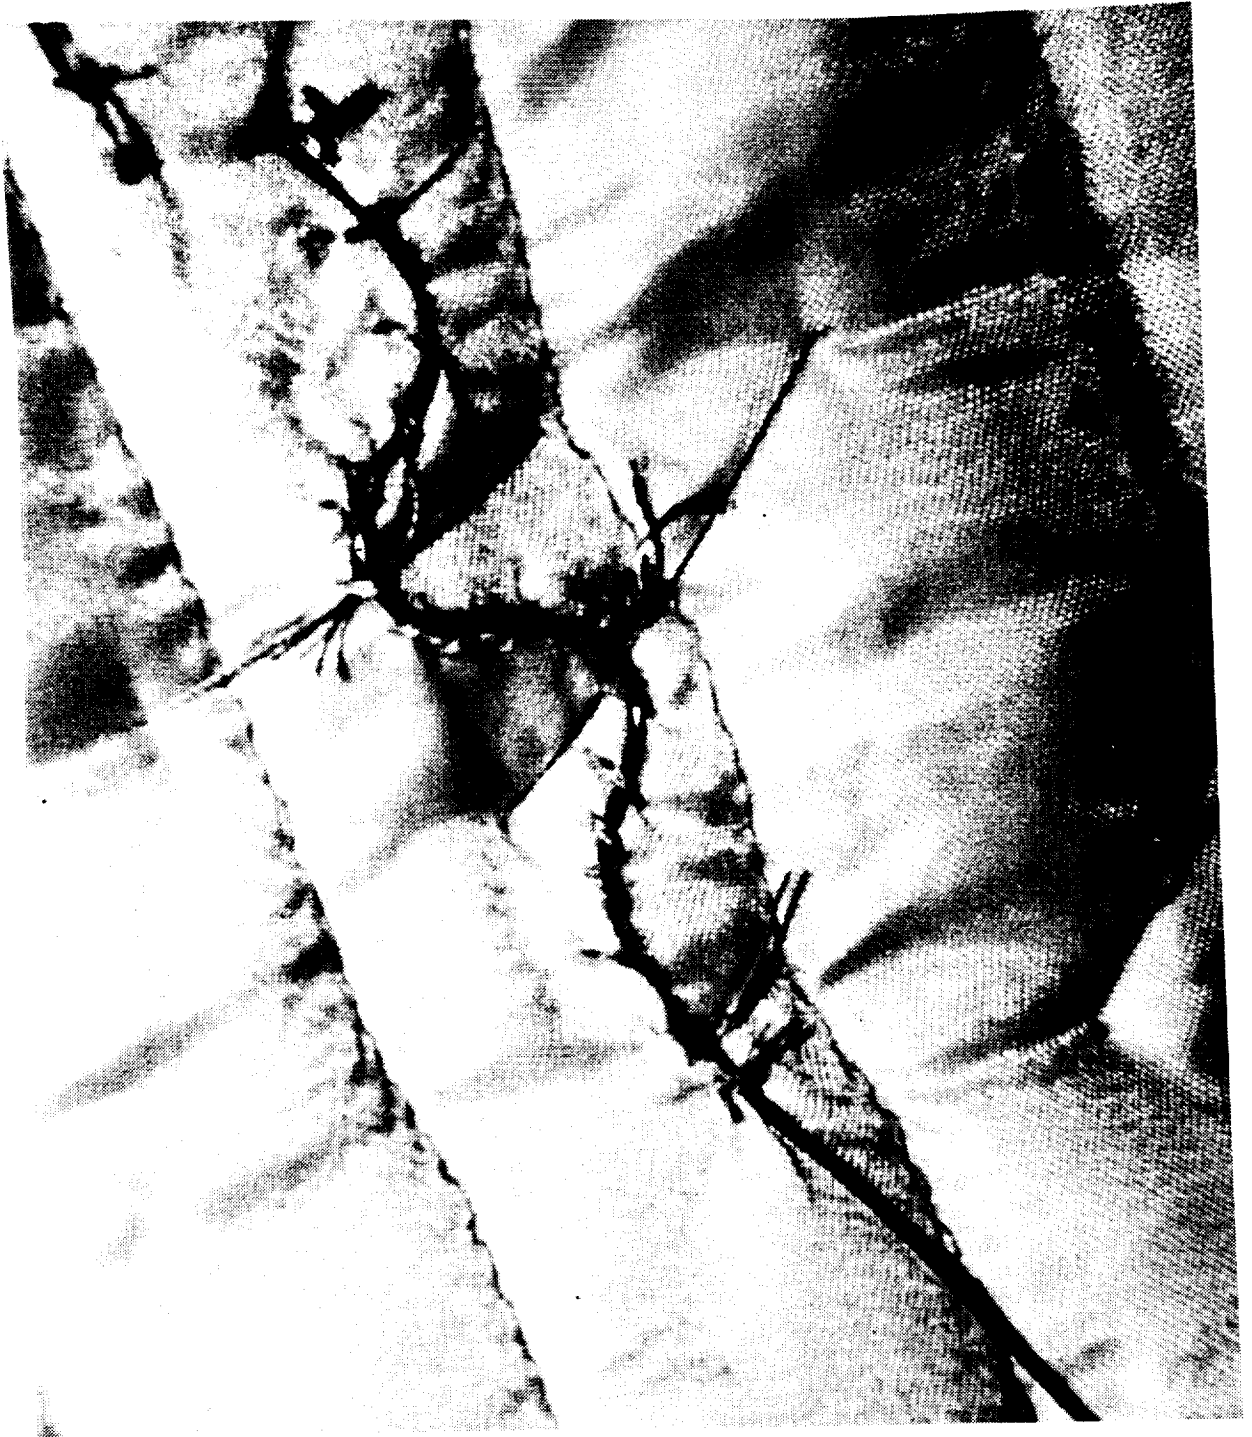
Figure 3-16: Method of Attachment of Sheathed Thermocouples to Cavity Wall Insulation.

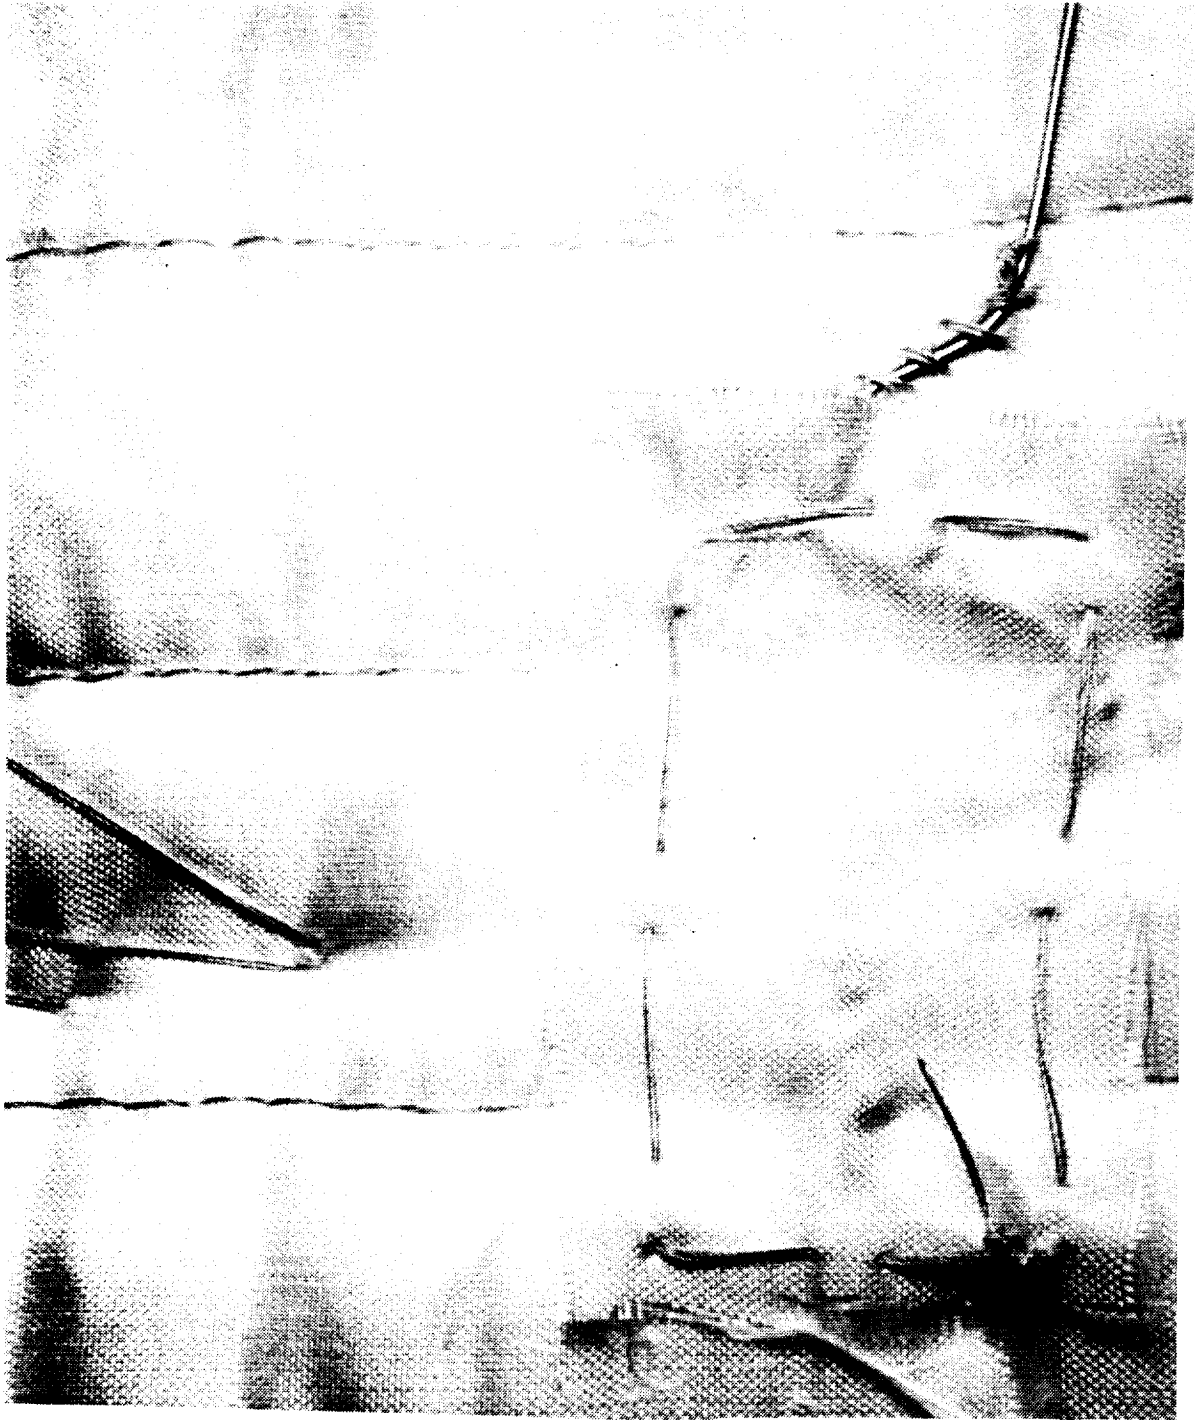
Figure 3-17: Method of Shielding Thermocouples Attached to the Cavity Insulation.

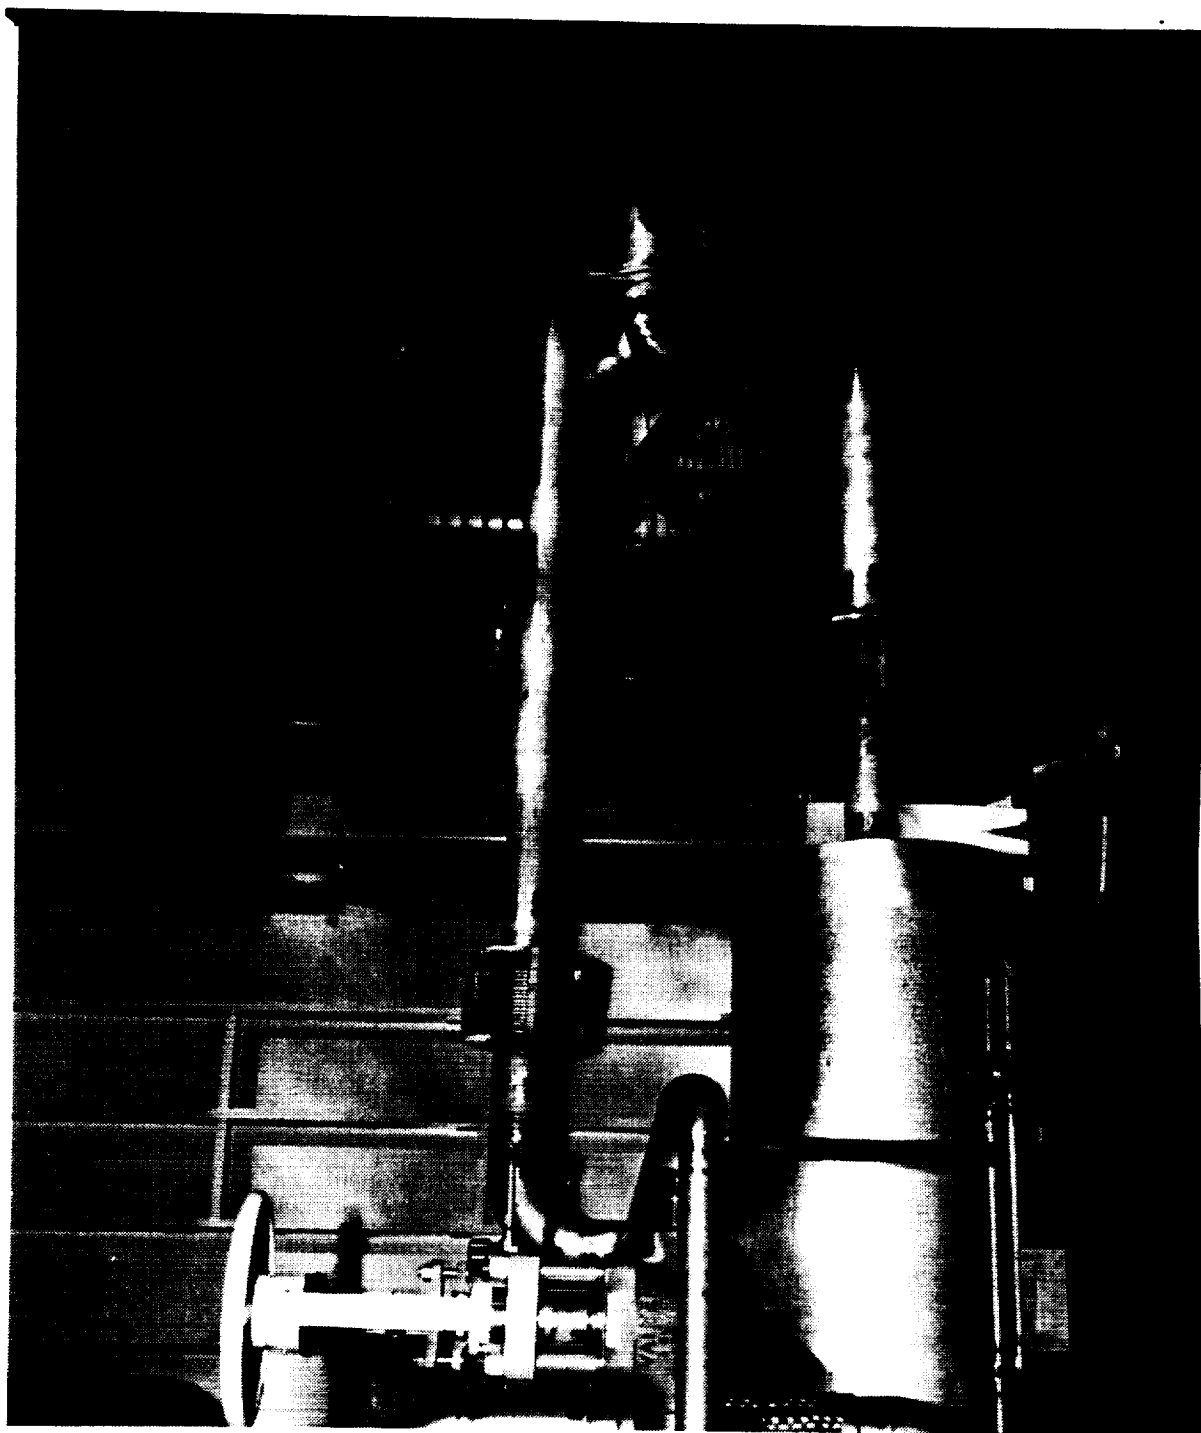
Figure 4-9: Inlet and Exit Gas Piping Runs Between CBC Engine Simulator and Vacuum Chamber.

The CBC engine simulator was placed beside the vacuum chamber and interconnecting piping was installed on 13 July 1990. Figure 4-9 shows the expansion bellows and piping runs between the vacuum chamber and CBC simulator pallet prior to insulating these lines. The piping runs were made from 102 mm (4-in) diameter schedule 40 stainless steel (316) pipe. Special high-temperature thermal feed-throughs were designed, fabricated, and installed in the chamber wall to keep vacuum chamber wall temperatures below 149°C (300°F). Figure 4-10 shows a close-up of the feed-through for the exiting gas line viewed from inside the vacuum chamber. A jumper was temporarily installed inside the chamber connecting the inlet and exit lines to allow operational checkout of the CBC prior to welding these connections to the receiver. The jumper was removed after the checkout was completed.

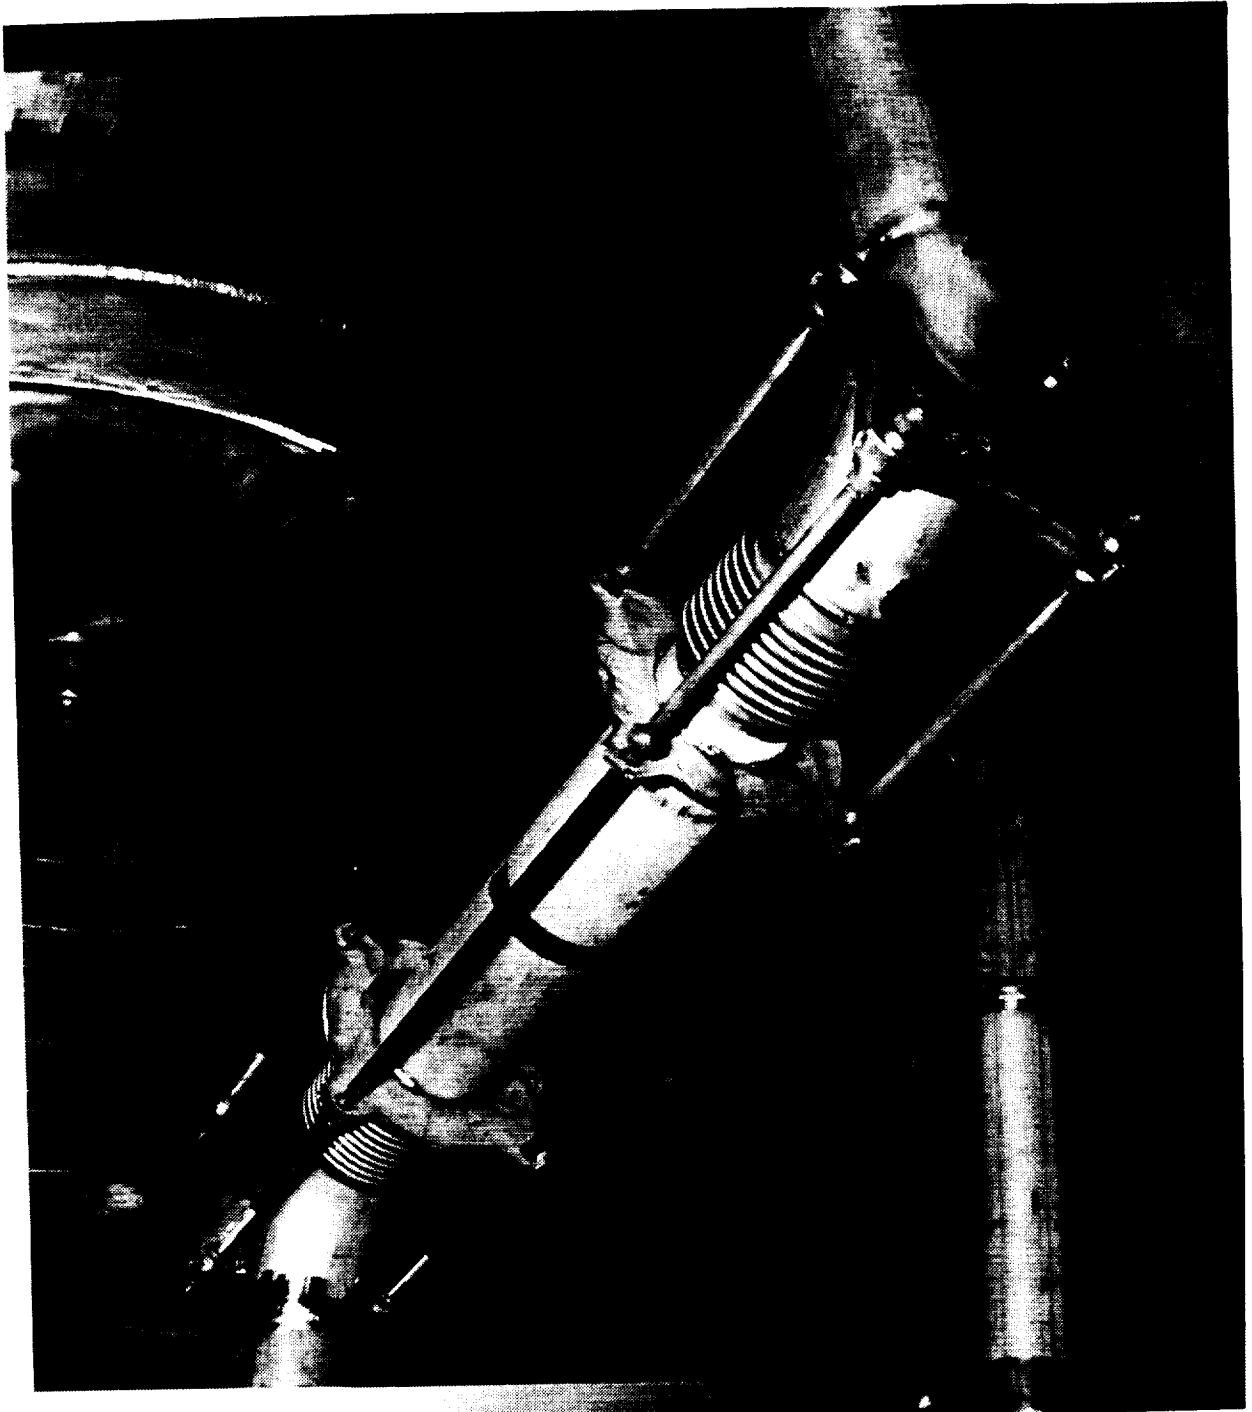
Figure 4-12: Expansion Bellows Configuration on the Cold (Inlet) Gas Line Between the Receiver and the Vacuum Chamber.

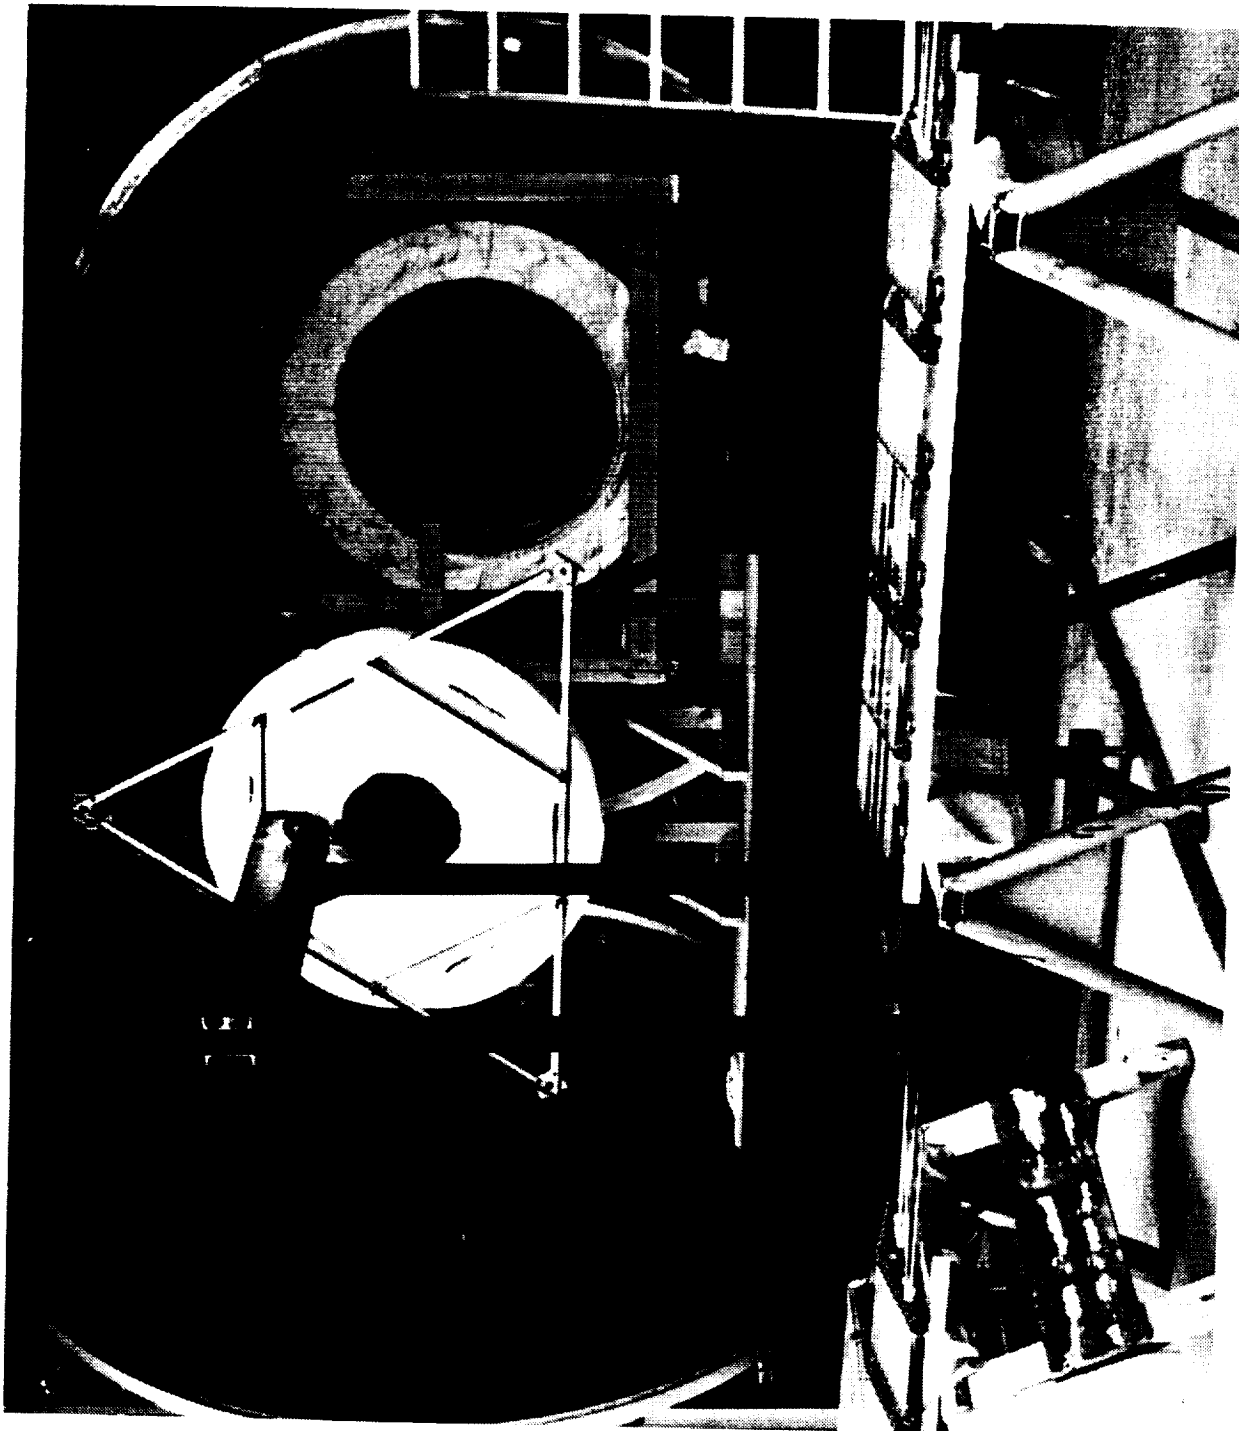
Figure 4-13: Cantilever Stand Supporting Columbium Box Beam and Receiver Aperture Plug During Final Assembly Operations of the Quartz Lamp Heater.

The cantilever stand shown in Figure 4-13 was used to support the quartz lamp heater structure during the assembly process. Figure 4-13 shows the front aperture assembly supported by the lamp array box beam prior to the installation of the six circumferential quartz lamp zones. The top lamp zone (Zone A) was assembled onto the box beam first as shown in Figure 4-14. Simple wood supports were used at each end of the heater to secure the aluminum rails that provided temporary support of the lamp zones. The wood supports were disassembled after the lamp zones were secured to each other by their ceramic insulated attachments. Figures 4-15 through 4-17 illustrate the assembly process at various stages in the operation. The zones were assembled in the following order: zone A, zones B and F, zones C and E, and zone D (zone A is the top zone and the zone letters increment clockwise around the circumference as viewed from the front, aperture end of the array). All parts were white-gloved handled during this assembly operation. Figure 4-17 shows the lamp array after all of the lamp zones were in place but prior to installing the ceramic insulators attaching zone D to zones C and E. After these were in place, the wood support structure was disassembled leaving the completed lamp array supported by the cantilever stand as shown in Figure 4-18.
